SMOKE TESTING OBSERVATION SUMMARY

Western Run Pilot Project - Baltimore Maryland

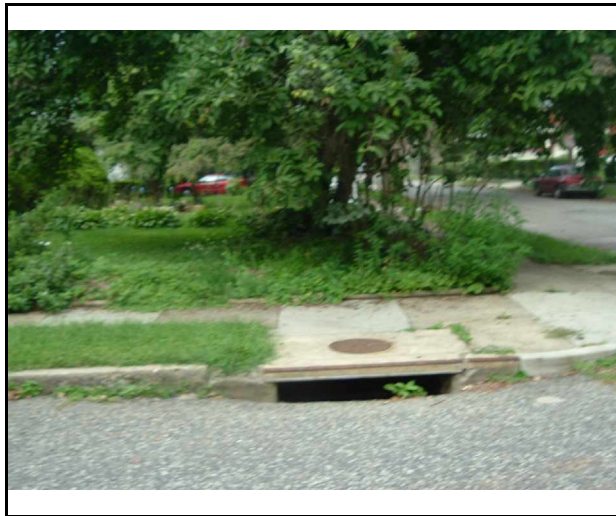
Photo No: 11

Source Type:	14= Catch Basin	Location:	6=Curb	Severity:
Sector:	1=Public	Drainage Area:	5000

Comments: Along side of 2505 - actually on Rusk Ave.

Unique Test ID	29	Date:	8/17/2004	MeterBasin:	01_WR18
Observer ID:	B	Crew:	T-1	Dye Test Recommended:	Y
Defect No:	5	Setup No:	2	Priority CCTV:

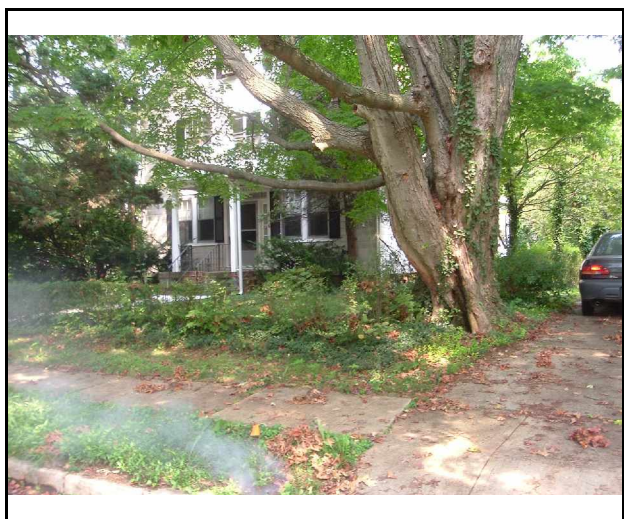
Photo No: 12

Source Type:	02= Service Line	Location:	6=Curb	Severity:
Sector:	1=Public	Drainage Area:	25

Comments: between curb & sidewalk

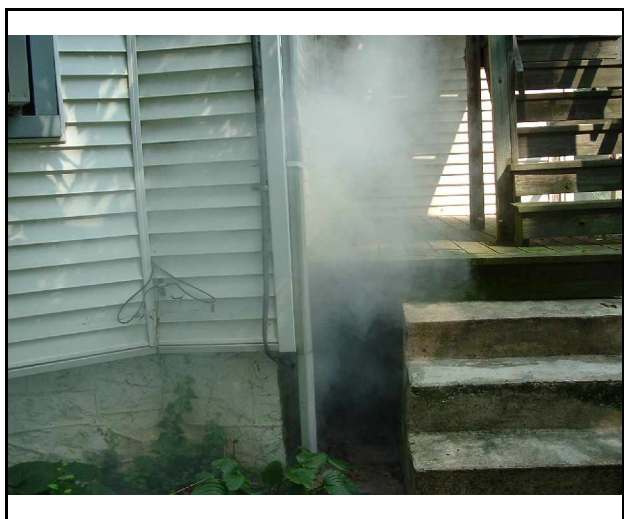
Photo No: 12

Source Type:	05= Downspout	Location:	8=Yard-Back	Severity:
Sector:	2=Private	Drainage Area:	150

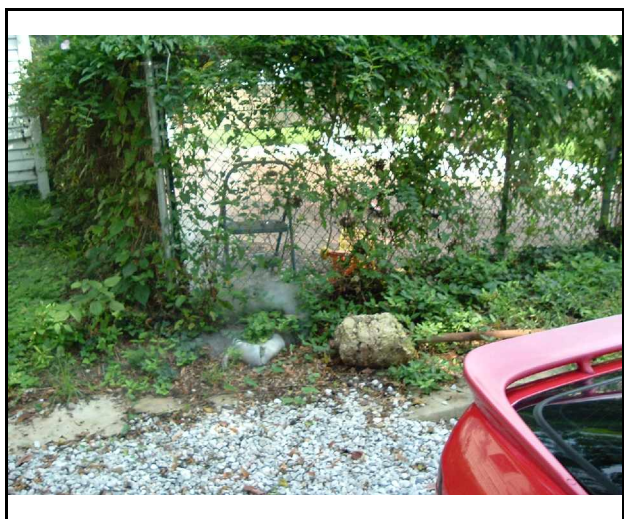
Photo No: 14

Source Type:	04= Cleanout	Location:	4=Driveway	Severity:
---------------------	--------------	------------------	------------	------------------

Comments: clean out

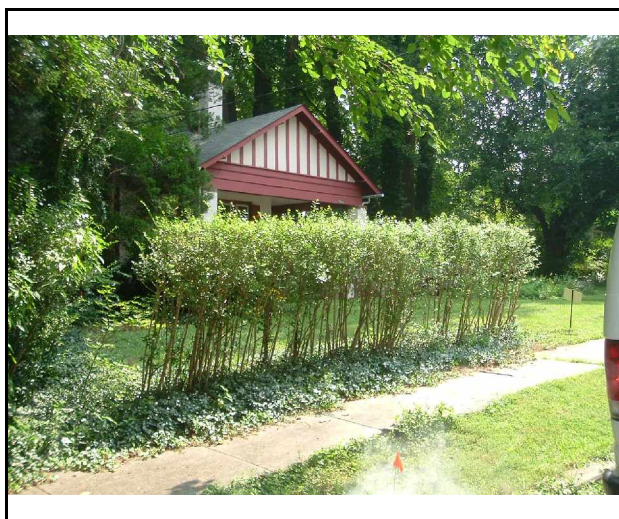
Photo No: 15

Source Type:	02= Service Line	Location:	5=Sidewalk	Severity:	4=Major
Sector:	1=Public	Drainage Area:	25

Comments: whole GRD between curb and sidewalk

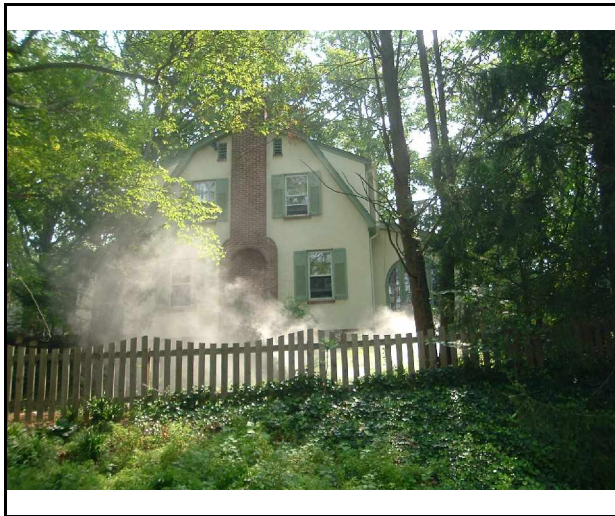
Photo No: 16

Source Type:	04= Cleanout	Location:	7=Yard-Front	Severity:
Sector:	2=Private	Drainage Area:	75	
Comments:	clean out

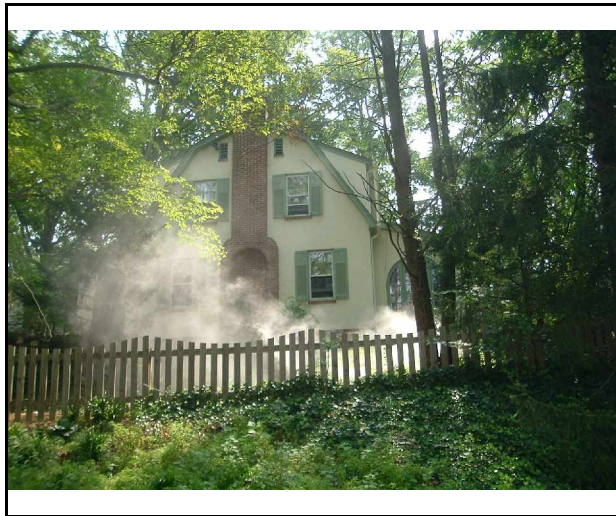
Photo No: 16

Source Type:	02= Service Line	Location:	7=Yard-Front	Severity:
Sector:	1=Public	Drainage Area:	75	
Comments:	hole in ground

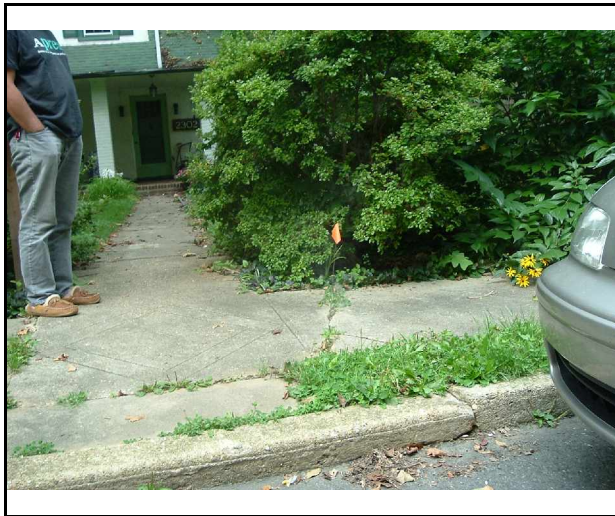
Photo No: 16

Source Type:	02= Service Line	Location:	1=Paved Concrete	Severity:
---------------------	------------------	------------------	------------------	------------------

Comments: crack in sidewalk

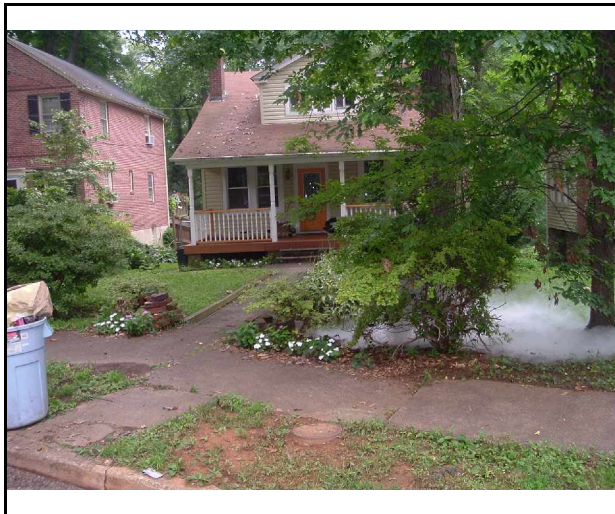
Photo No: 1

Source Type:	04= Cleanout	Location:	7=Yard-Front	Severity:
Sector:	2=Private	Drainage Area:	25

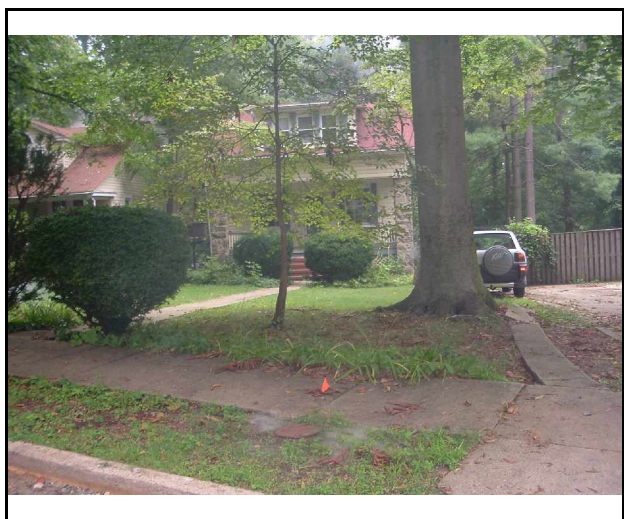
Photo No: 2

Source Type:	18= Other	Location:	5=Sidewalk	Severity:
Sector:	1=Public	Drainage Area:	50

Comments: water meter

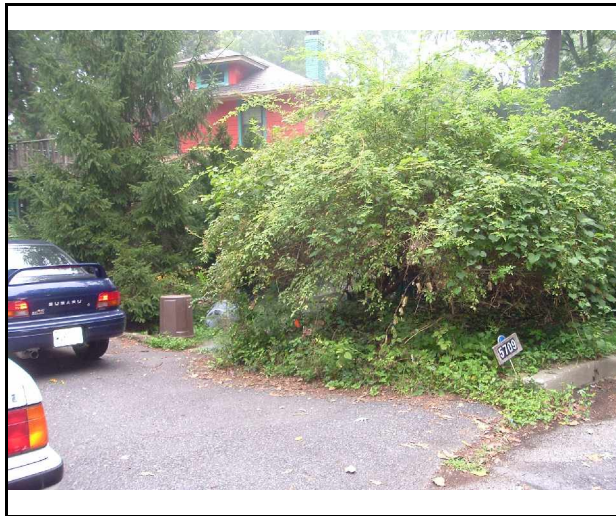
Photo No: 3

Source Type:	12= MH Frame Seal	Location:	5=Sidewalk	Severity:
Sector:	1=Public	Drainage Area:	100	
Comments:	mahole in brush

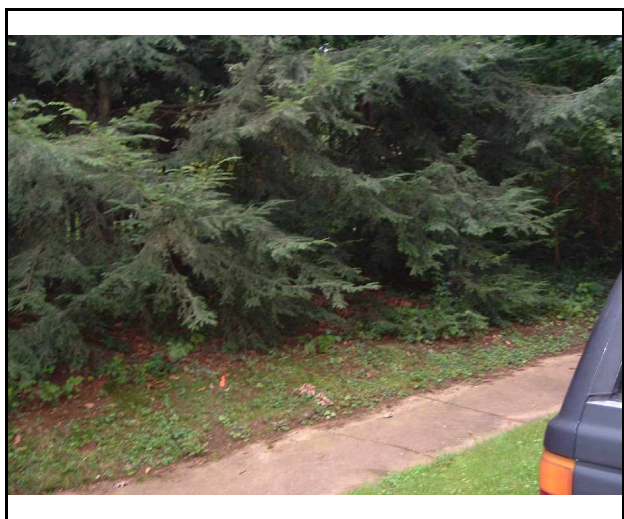
Photo No: 1

Source Type:	18= Other	Location:	9=Yard-Side	Severity:
Sector:	2=Private	Drainage Area:	150	
Comments:	holes in ground

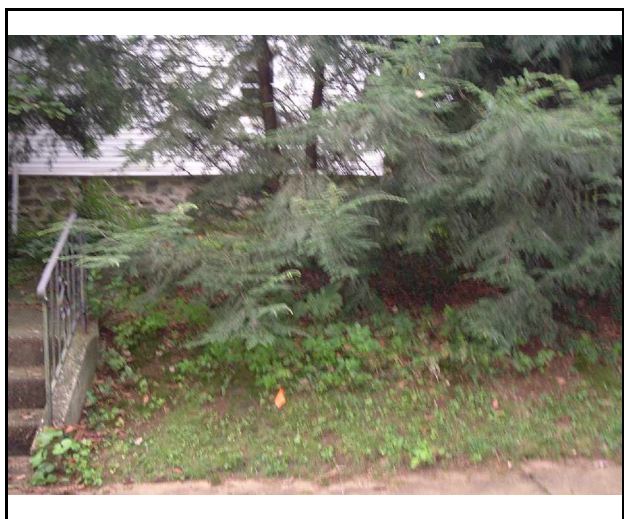
Photo No: 2

Source Type:	18= Other	Location:	9=Yard-Side	Severity:
Sector:	2=Private	Drainage Area:	150	
Comments:	holes in ground

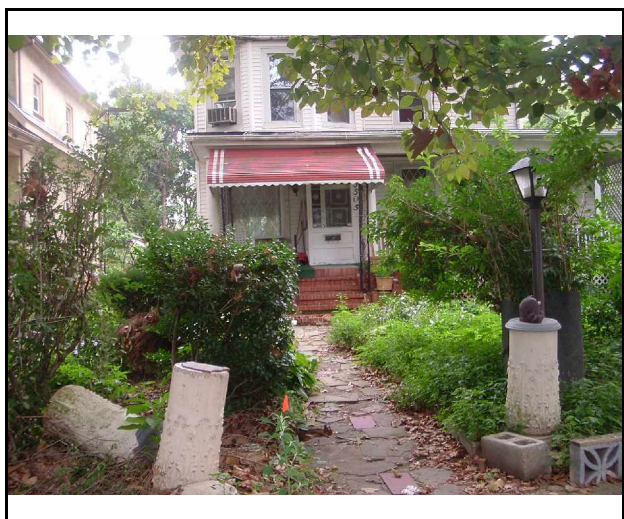
Source Type:	04= Cleanout	Location:	7=Yard-Front	Severity:
Sector:	2=Private	Drainage Area:	0	
Comments:	C.O above ground
